**Flood Control Project Maintenance
Levee Inspections**
LMA District Cover Sheet
Spring 2018 Levee Inspection Results

Butte County Department of Public Works

Unit Cover Sheet

Spring 2018 Levee Inspection Results

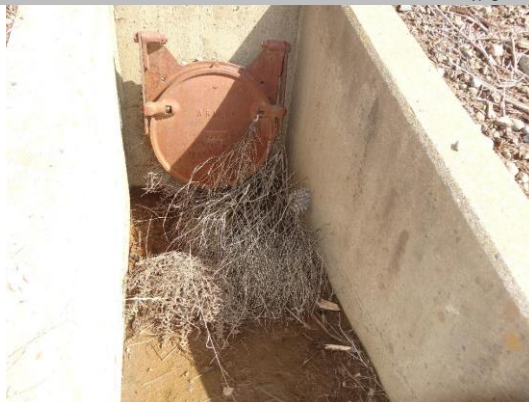
Photo 1 of 3 : UCIP_SP_2018_31901_58194.jpg

LM Start	3.08	Rating **	M	Issue No.	32
LM End	3.08	Issue Type +	Ma	Location *	
Category	Supplemental		GPS Latitude/Longitude		
			Start	End	
Item	DWR UCIP LMA Responsibility		39.778016 °	39.778016 °	
			-121.854460 °	-121.854460 °	
DWR ID					
Comment Code					
Inspector Comment					
FS_ID:31901 DS_ID:19269 EP_NO: N/A Repair Type: Non-Urgent Crossing Status: Found UCIP Comments: Needs cleaning and clearing the culvert. FIELD_STRUCT_DESC: 24-inch corrugated metal gravity drainage pipe through the levee, 11 feet below the crown. Flap gate on the waterside (WS) end. Concrete U-shaped headwall on each end. Grouted riprap apron on the landside (LS) end. Grouted riprap spillway on the WS end. [Additional Reference(s): DWR Levee Log, 1992. USACE Sacramento O&M Manual 504, May 1965, (HLM 3.16)]. FS Date: 3/7/2014

WS view: U type concrete headwall, flapgate, and CMP on levee slope.
Needs cleaning and clearing.

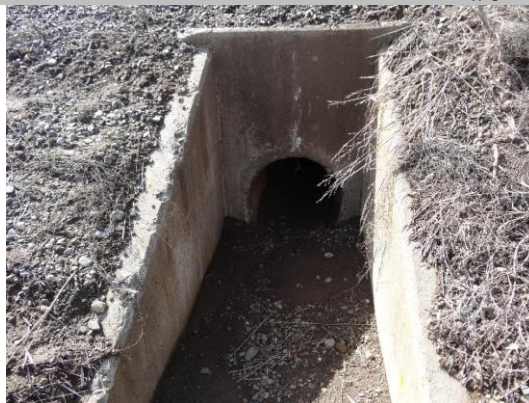
Photo 2 of 3 : UCIP_SP_2018_31901_58193.jpg

LS view: U type concrete headwall and CMP on levee slope. Soil/mud on inlet box.

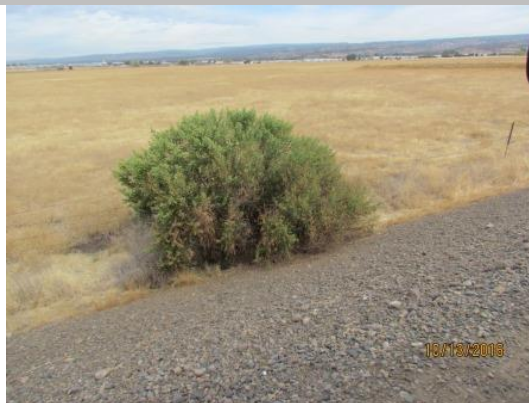
Photo 1 of 1 : SP_2018_NA0003_67_14_20180305_00003.jpg

LM Start	3.38	Rating **	M	Issue No.	14
LM End	3.38	Issue Type +	Ma	Location *	LS
Category	Earthen Levee			GPS Latitude/Longitude	
				Start	End
Item	Vegetation			39.777429 °	39.777429 °
				-121.848937 °	-121.848937 °
DWR ID	DWR_NA0003_03_f_2016_14				
Comment Code					
V2 : Remove the wild growth other than native grasses from the levee slopes.					
Inspector Comment

View of a bush along the landside toe.

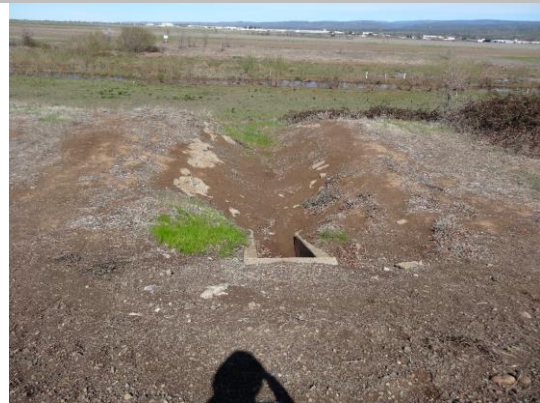
Photo 1 of 3 : UCIP_SP_2018_32026_58520.jpg

LM Start	0.27	Rating **	M	Issue No.	25
LM End	0.27	Issue Type +	Ma	Location *	
Category	Supplemental			GPS Latitude/Longitude	
				Start	End
Item	DWR UCIP LMA Responsibility			39.776554 °	39.776554 °
				-121.850730 °	-121.850730 °
DWR ID					
Comment Code					
Inspector Comment					
FS_ID:32026 DS_ID:19279 EP_NO: N/A Repair Type: Non-Urgent Crossing Status: Found UCIP Comments: Needs cleaning and clearing the culvert. FIELD_STRUCT_DESC: 24-inch corrugated metal gravity drainage pipe through the levee, 10 feet below the crown. Flap gate on the waterside (WS) end. Concrete U-shaped headwall on each end. Grouted riprap apron on the landside (LS) end. Grouted riprap spillway on the WS end. [Additional Reference(s): DWR Levee Log, 1992. USACE Sacramento O&M Manual 504, May 1965, (HLM 0.28)]. FS Date: 3/7/2014

WS view: concrete headwall and grouted riprap spillway on levee slope.

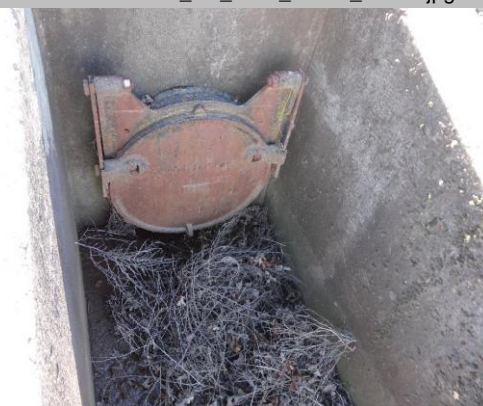
Photo 2 of 3 : UCIP_SP_2018_32026_58519.jpg

WS view: U type concrete headwall and CMP on levee slope. Mud and vegetation debris on outlet box.

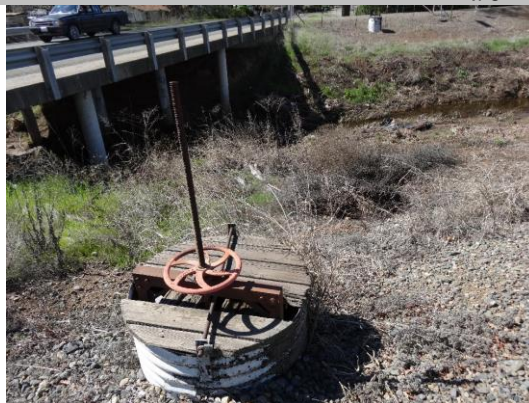
Photo 1 of 3 : UCIP_SP_2018_32025_58512.jpg

WS view: slide gate in CMP riser on waterside shoulder.

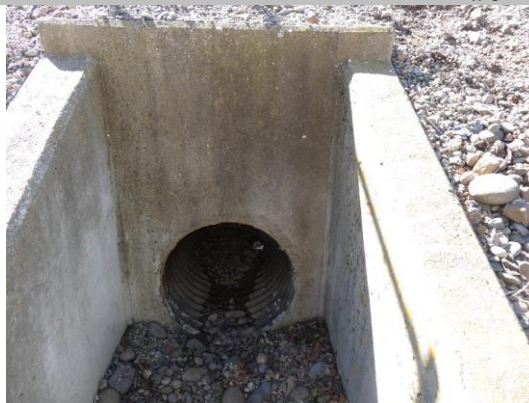
Photo 2 of 3 : UCIP_SP_2018_32023_58504.jpg

LS view: U type concrete headwall and CMP on levee slope. Pebbles and mud on inlet box.

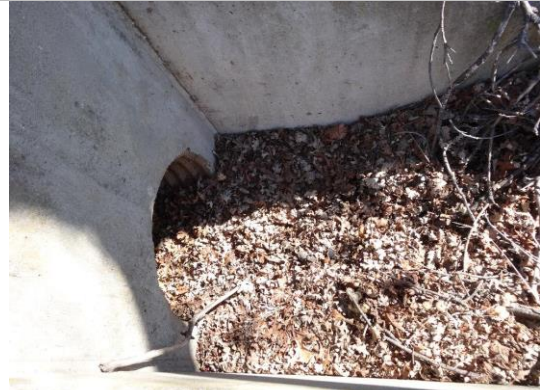
Photo 2 of 2 : UCIP_SP_2018_32143_58640.jpg

LM Start	0.92	Rating **	M	Issue No.	28 (cont)
LM End	0.92	Issue Type +	Ma	Location *	
Category	Supplemental			GPS Latitude/Longitude	
				Start	End
Item	DWR UCIP LMA Responsibility			39.775704 °	39.775704 °
				-121.850901 °	-121.850901 °
DWR ID					
Comment Code					
Inspector Comment					
FS_ID:32143					
DS_ID:19287					
EP_NO: N/A					
Repair Type: Non-Urgent					
Crossing Status: Found					
UCIP Comments: Needs cleaning and clearing the culvert.					
FIELD_STRUCT_DESC: 24-inch corrugated metal gravity drainage pipe through the levee, 9 feet below the crown. Flap gate on the waterside (WS) end. Concrete U-shaped headwall on each end. Grouted riprap apron on the landside (LS) end. Grouted riprap spillway on the WS end. [Additional Reference(s): DWR Levee Log, 1992. USACE Sacramento O&M Manual 504, May 1965, (HLM 0.96)].					
FS Date: 3/7/2014

LS view: U type concrete headwall and CMP on levee slope. Vegetation and mud on inlet box.

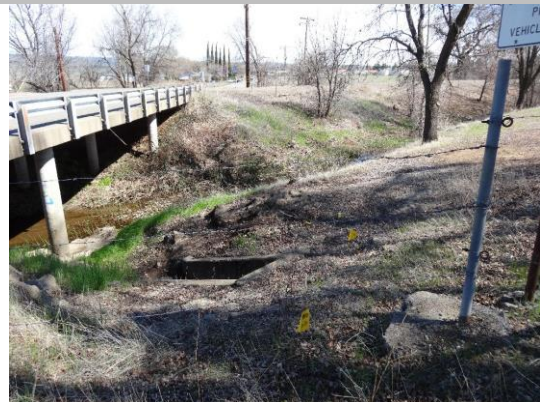
Photo 1 of 2 : UCIP_SP_2018_31946_58357.jpg

LM Start	0.92	Rating **	M	Issue No.	29
LM End	0.92	Issue Type +	En	Location *	
Category	Supplemental			GPS Latitude/Longitude	
				Start	End
Item	DWR UCIP Field Study			39.775729 °	39.775729 °
				-121.850950 °	-121.850950 °
DWR ID					
Comment Code					
Inspector Comment					
FS_ID:31946 DS_ID:19293 EP_NO: 15950 Repair Type: Non-Urgent Crossing Status: Indicator Found UCIP Comments: Only little gasoline indicator flags found on both sides of the levee and across the creek. FIELD_STRUCT_DESC: 6-inch high-pressure natural gas main line of an unknown material through both levees and under Dry Creek, 2 feet below the crown. (Plans to place a 6-inch high-pressure gas main under both levees and creek bed to a depth of 5 feet across Dry Creek authorized under Permit No. 15950, 1992 - Pacific Gas and Electric Company [PG&E]). FS Date: 3/7/2014

WS view: little gasoline indicator (yellow flags) on both sides of the levee.

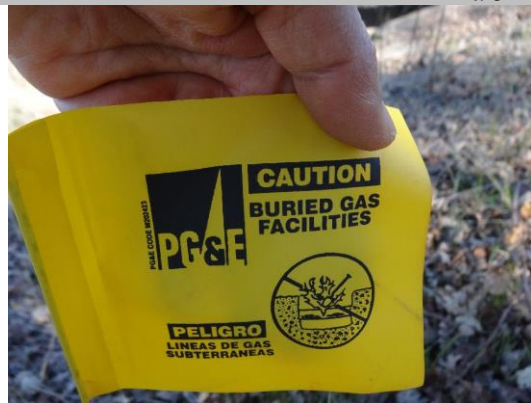
Photo 2 of 2 : UCIP_SP_2018_31946_58356.jpg

WS view: close up view of little gasoline indicator.

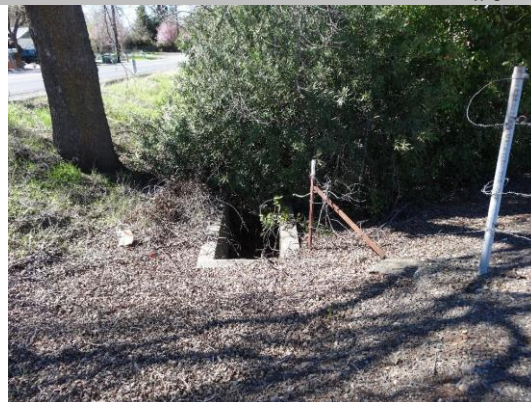
Photo 1 of 3 : UCIP_SP_2018_32144_58644.jpg

LM Start	0.94	Rating **	M	Issue No.	30
LM End	0.94	Issue Type +	Ma	Location *	
Category	Supplemental			GPS Latitude/Longitude	
				Start	End
Item	DWR UCIP LMA Responsibility			39.775899 °	39.775899 °
				-121.851124 °	-121.851124 °
DWR ID					
Comment Code					
Inspector Comment					
FS_ID:32144 DS_ID:19288 EP_NO: N/A Repair Type: Non-Urgent Crossing Status: Found UCIP Comments: Slide gate in CMP riser on waterside. No access to CMP riser.Needs cleaning and clearing the culvert. FIELD_STRUCT_DESC: 24-inch corrugated metal gravity drainage pipe through the levee and under the channel, 9.5 feet below the crown. Slide gate in a pipe riser on the waterside (WS) slope. Concrete U-shaped headwall on the landside (LS) end. [Additional Reference(s): DWR Levee Log, 1992. USACE Sacramento O&M Manual 504, May 1965, (HLM 0.98)]. FS Date: 3/7/2014

LS view: U type concrete headwall of CMP culvert on levee slope.
Vegetation debris and mud on inlet box.

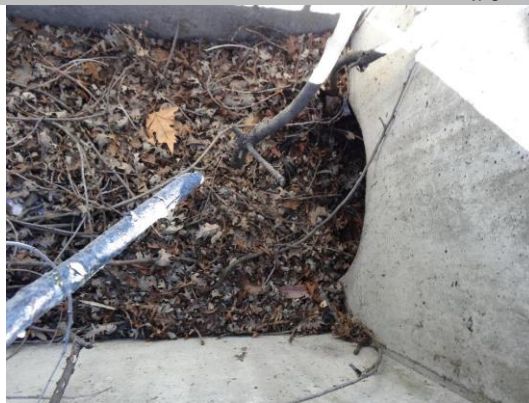
Photo 2 of 3 : UCIP_SP_2018_32144_58643.jpg

LS view: close view of vegetation debris and mud on inlet box.

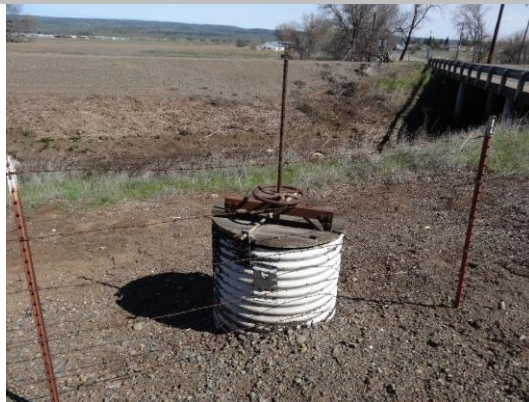
Photo 3 of 3 : UCIP_SP_2018_32144_58642.jpg

WS view: slide gate in CMP riser on waterside. No access to CMP riser.

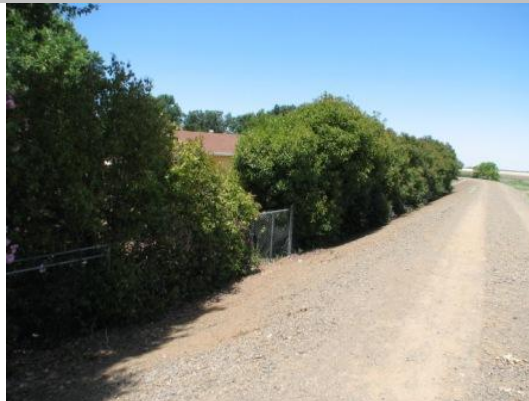
Photo 1 of 1 : SP_2018_NA0003_68_1_20180305_00001.jpg

LM Start	0.94	Rating **	M	Issue No.	1
LM End	1.01	Issue Type +	En	Location *	LS
Category	Earthen Levee			GPS Latitude/Longitude	
				Start	End
Item	Encroachments			39.776013 °	39.776595 °
				-121.851175 °	-121.852005 °
DWR ID	DWR_NA0003_04_s_2012_1				
Comment Code					
FE : Fence					
Inspector Comment					
Chainlink fences are unpermitted.

View of the fence and trees along the landside toe of the levee.

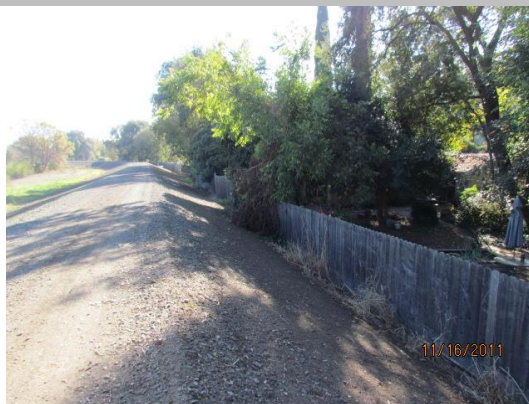
Photo 1 of 1 : SP_2018_NA0003_68_3_20180305_00003.jpg

LM Start	1.11	Rating **	U	Issue No.	3
LM End	1.22	Issue Type +	En	Location *	LS
Category	Earthen Levee			GPS Latitude/Longitude	
				Start	End
Item	Encroachments			39.776760 °	39.777650 °
				-121.854022 °	-121.855687 °
DWR ID	DWR_NA0003_04_s_2012_3				
Comment Code					
FE : Fence					
Inspector Comment

View of the fence along the landside toe.

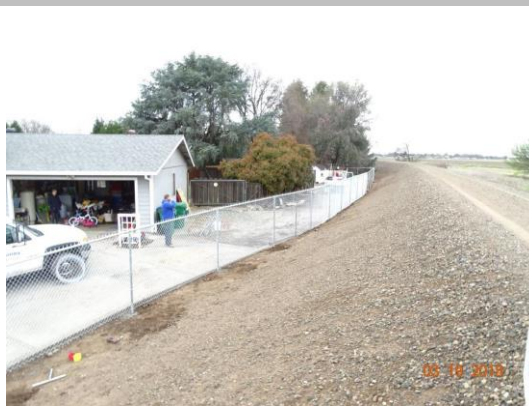
Photo 1 of 1 : SP_2018_NA0003_68_22_20180402_00039.jpg

LM Start	1.23	Rating **	M	Issue No.	22
LM End	1.27	Issue Type +	En	Location *	LS
Category	Earthen Levee			GPS Latitude/Longitude	
				Start	End
Item	Encroachments			39.777700 °	39.777988 °
				-121.855877 °	-121.856448 °
DWR ID	DWR_NA0003_04_s_2018_22				
Comment Code					
FE : Fence					
Inspector Comment					
Butte County is writing a letter requesting that landowner to remove the fence.

View of the fence being built without a permit.

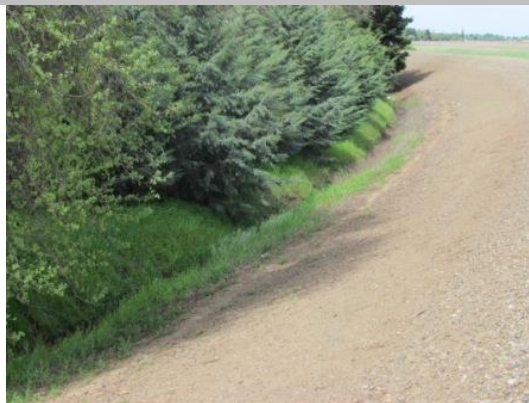
Photo 1 of 1 : SP_2018_NA0003_68_2_20180305_00002.jpg

LM Start	1.27	Rating **	M	Issue No.	2
LM End	1.36	Issue Type +	En	Location *	LS
Category	Earthen Levee			GPS Latitude/Longitude	
				Start	End
Item	Encroachments			39.778003 °	39.778378 °
				-121.856403 °	-121.857953 °
DWR ID	DWR_NA0003_04_s_2012_2				
Comment Code					
DT : Ditch					
Inspector Comment

View of ditch at the landside toe.

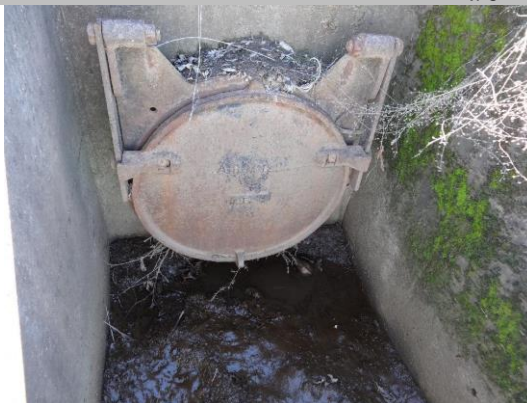
Photo 1 of 2 : UCIP_SP_2018_31964_58389.jpg

WS view: U type concrete headwall and CMP on levee slope. Vegetation debris and mud in outlet box. Needs cleaning and clearing.

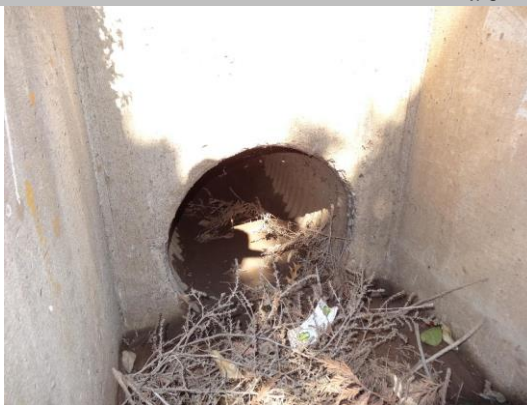
Photo 2 of 2 : UCIP_SP_2018_31964_58388.jpg

LS view: U type concrete headwall and CMP on levee slope. Vegetation debris and mud in inlet box.

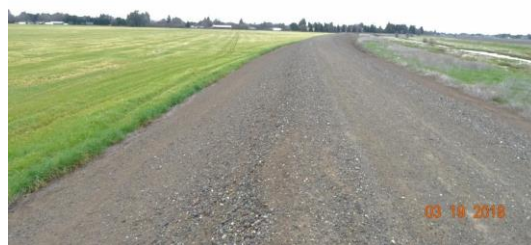
Photo 1 of 1 : SP_2018_NA0003_68_16_20180402_00038.jpg

LM Start	1.54	Rating **	A	Issue No.	16
LM End	1.54	Issue Type +	Ma	Location *	LS
Category	Earthen Levee			GPS Latitude/Longitude	
				Start	End
Item	Vegetation			39.778605 °	39.778605 °
				-121.861485 °	-121.861485 °
DWR ID	DWR_NA0003_04_s_2018_16				
Comment Code					
V1 : Control annual grass and weeds on the levee slopes and easements.					
Inspector Comment					
There is no vegetation on both slopes.

View of the levee with no vegetation on both slopes.

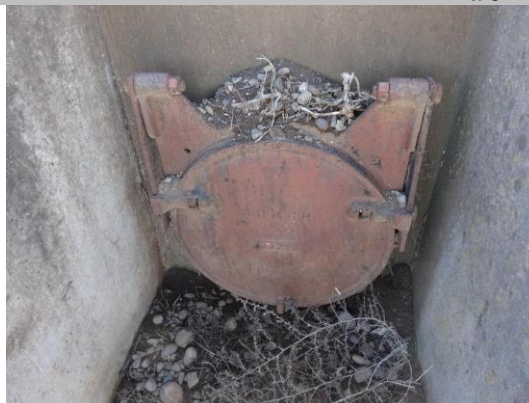
Photo 1 of 3 : UCIP_SP_2018_31965_58395.jpg

WS view: U type concrete headwall and CMP on levee slope. Vegetation debris and mud in outlet box. Needs cleaning and clearing.

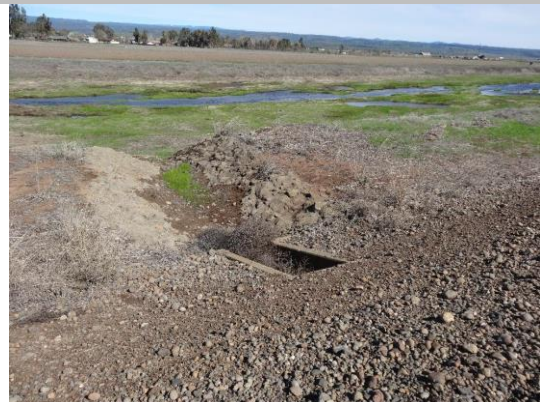
Photo 1 of 3 : UCIP_SP_2018_31966_58401.jpg

WS view: U type concrete headwall and grouted riprap spillway on levee slope.

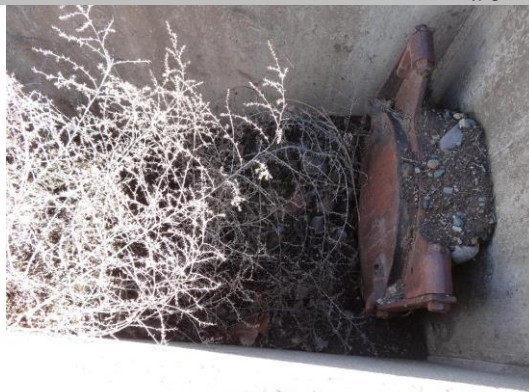
Photo 2 of 3 : UCIP_SP_2018_31966_58400.jpg

WS view: U type concrete headwall and CMP on levee slope. Vegetation debris and mud on outlet box. Needs cleaning and clearing.

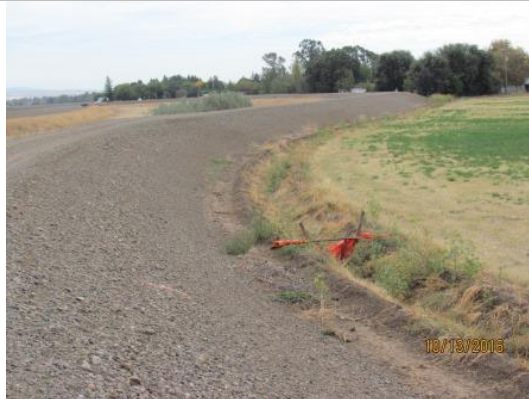
Photo 1 of 1 : SP_2018_NA0003_68_24_20180305_00010.jpg

LM Start	2.49	Rating **	M	Issue No.	24
LM End	2.61	Issue Type +	En	Location *	LS
Category	Earthen Levee			GPS Latitude/Longitude	
				Start	End
Item	Encroachments			39.784408 °	39.785619 °
				-121.877053 °	-121.878604 °
DWR ID	DWR_NA0003_04_f_2016_24				
Comment Code					
DT : Ditch					
Inspector Comment

View of a ditch along the landside toe.

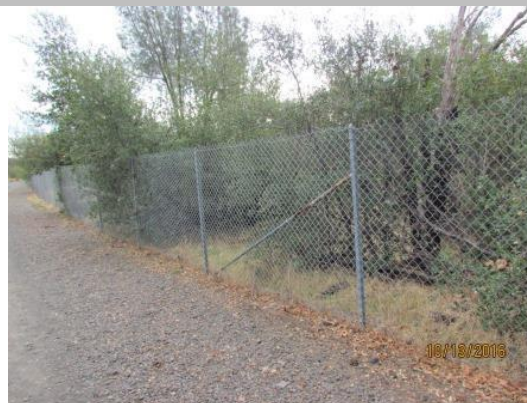
Photo 1 of 1 : SP_2018_NA0003_69_12_20180305_00010.jpg

LM Start	0.50	Rating **	M	Issue No.	12
LM End	0.82	Issue Type +	Ma	Location *	LS
Category	Earthen Levee			GPS Latitude/Longitude	
				Start	End
Item	Trim / Thin Trees			39.761836 °	39.763507 °
				-121.797316 °	-121.802545 °
DWR ID	DWR_NA0003_05_f_2016_12				
Comment Code					
T2 : Thin trees to allow visibility of the ground and room to flood fight.					
Inspector Comment

View of the trees along the landside slope.

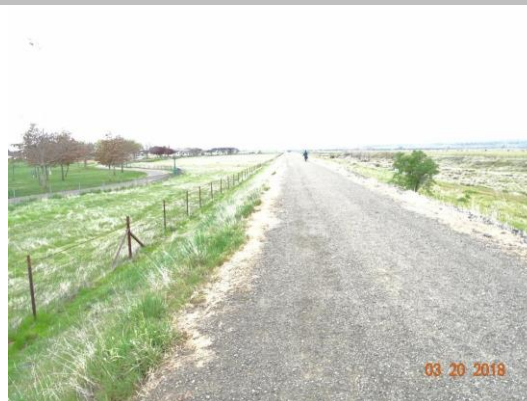
Photo 1 of 2 : SP_2018_NA0003_69_14_20180402_00014.jpg

LM Start	0.85	Rating **	A	Issue No.	14
LM End	1.85	Issue Type +	Ma	Location *	LS
Category	Earthen Levee			GPS Latitude/Longitude	
				Start	End
Item	Vegetation			39.764702 °	39.775426 °
				-121.803562 °	-121.814201 °
DWR ID	DWR_NA0003_05_f_2017_14				
Comment Code					
V2 : Remove the wild growth other than native grasses from the levee slopes.					
Inspector Comment					
There is native grasses from both slopes.

View of the levee with native vegetation on both slopes.

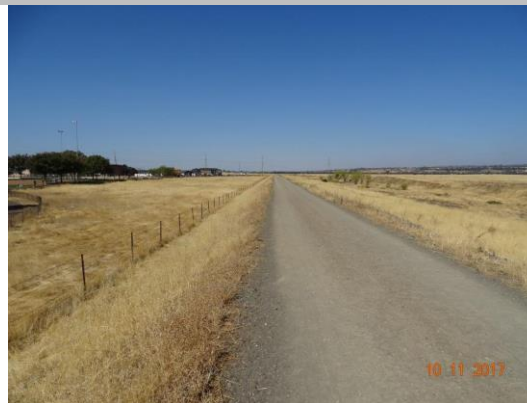
Photo 2 of 2 : SP_2018_NA0003_69_14_20180305_00012.jpg

LM Start	0.85	Rating **	A	Issue No.	14 (cont)	
LM End	1.85	Issue Type +	Ma	Location *	LS	
Category	Earthen Levee			GPS Latitude/Longitude		
				Start		End
Item	Vegetation			39.764702 °		39.775426 °
				-121.803562 °		-121.814201 °
DWR ID	DWR_NA0003_05_f_2017_14					
Comment Code						
V2 : Remove the wild growth other than native grasses from the levee slopes.						
Inspector Comment						
There is native grasses from both slopes.

View of native grasses on both slopes.

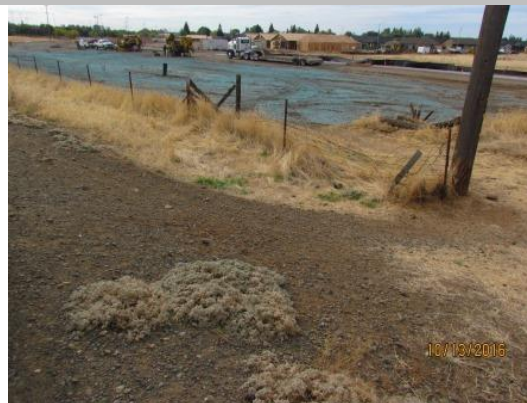
Photo 1 of 1 : SP_2018_NA0003_69_13_20180305_00011.jpg

LM Start	1.25	Rating **	M	Issue No.	13
LM End	1.25	Issue Type +	Ma	Location *	LS
Category	Earthen Levee			GPS Latitude/Longitude	
				Start	End
Item	Slope Stability			39.768621 °	39.768621 °
				-121.807052 °	-121.807052 °
DWR ID	DWR_NA0003_05_f_2016_13				
Comment Code					
S2 : Repair the levee slope damaged by foot traffic and prevent access where possible.					
Inspector Comment

View of the damaged slope by foot traffic.

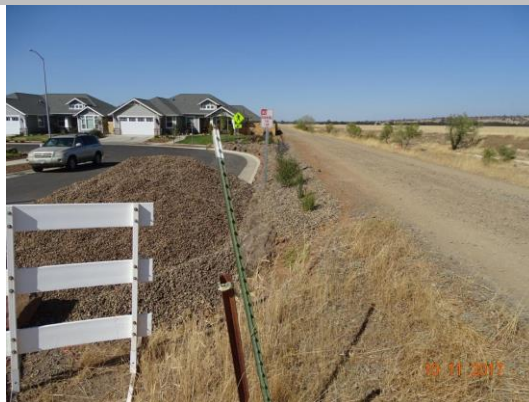
Photo 1 of 1 : SP_2018_NA0003_69_15_20180305_00013.jpg

LM Start	1.56	Rating **	U	Issue No.	15							
LM End	1.56	Issue Type +	En	Location *	LS							
Category	Earthen Levee		GPS Latitude/Longitude									
			Start	End								
Item	Encroachments		39.772190 °	39.772190 °								
			-121.810700 °	-121.810700 °								
DWR ID	DWR_NA0003_05_f_2017_15											
Comment Code												
RW : Retaining Wall												
Inspector Comment												
The developer cut a paved road, gutter and large rocks in slope/toe of the levee. I asked Butte County Public Works to send the developer an enforcement letter regarding this encroachment.

View of the housing track road cutting into the levees slope and toe.
